LFMP / Perpignan Rivesaltes / PGF

The purpose of this page is to draw the attention of commercial and general aviation pilots to the aeronautical context and the main threats associated with an aerodrome. The identification of these threats is the result of a collaborative effort between airfield operators (air operators, airfield operator, air navigation service providers, flying clubs, Météo-France, etc.) by comparing the elements of their safety management systems (SMS). The members of the Local Safety Team (LST) validated this information.

Summary

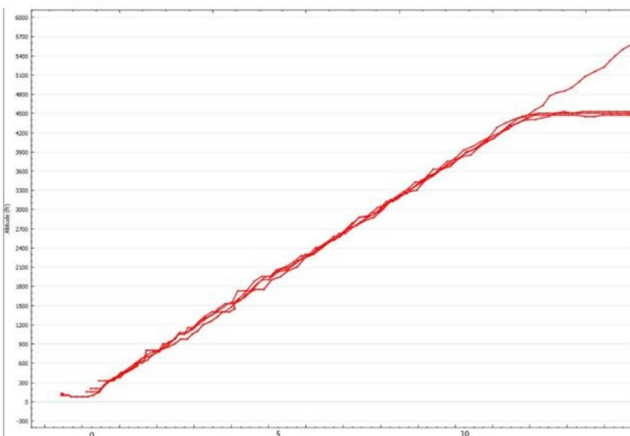
The trajectory of the RNP RWY15 instrument approach procedure at Perpignan flies over a mountainous environment. Since its entry into service in 2020, several in-flight reports of Terrain Awareness Warning System (TAWS) alerts have been sent to the DSNAs by crews using this procedure. The causes identified for these alerts are, depending on the case :

- **The aircraft was put into landing configuration late, with excessive indicated airspeed and/or vertical speed,**
- **Insufficient resolution of the terrain mesh around the approach procedure in the ground database of the aircraft's GPWS - E-GPWS.**

Profils comparés (2 APP en ALR + 2 APP sans ALR)

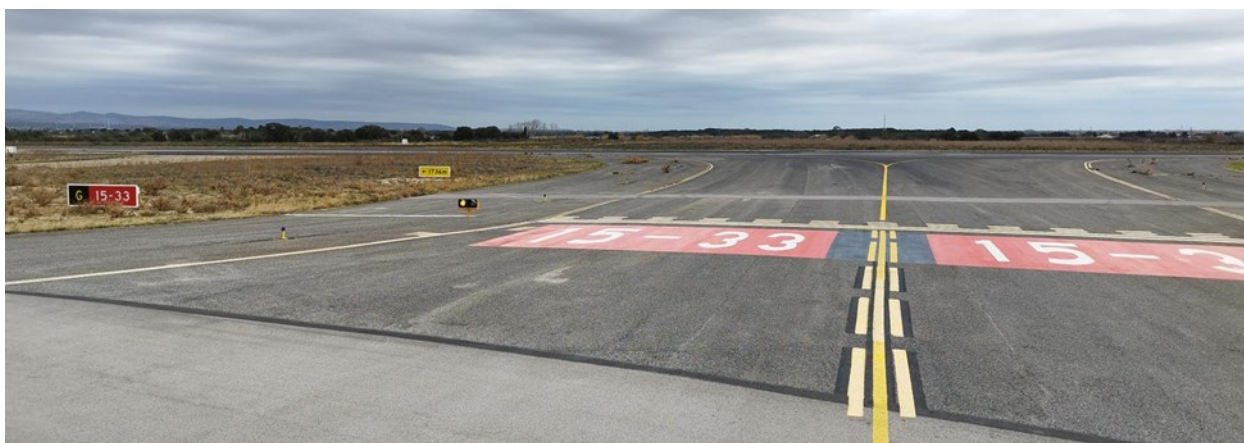
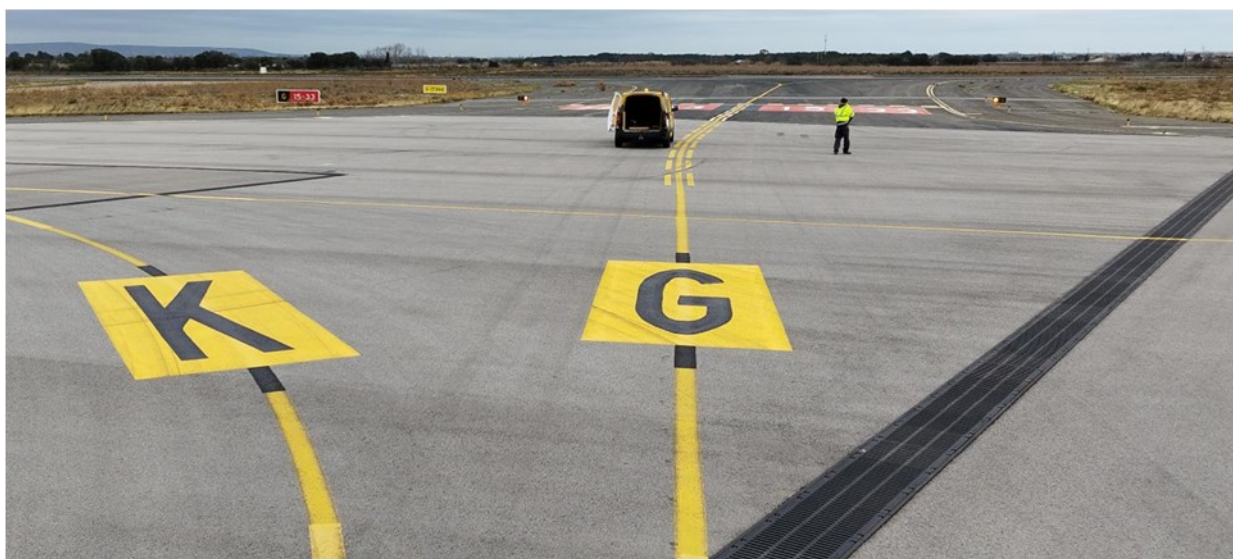
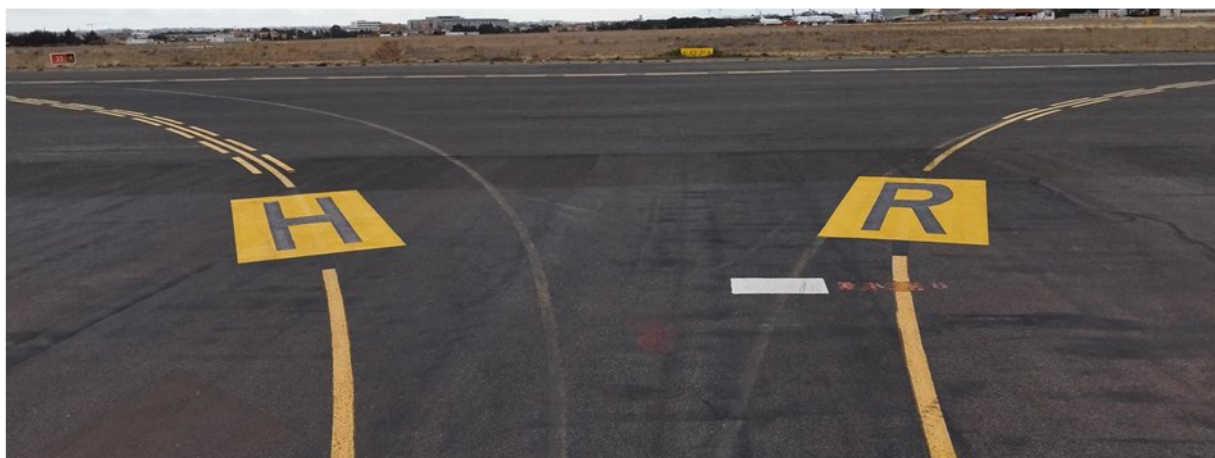
Very short runway access taxiways: **HOT SPOTS ROMEO, GOLF, HOTEL**

The taxiways to the runway holding points are very short on Romeo, Golf and Hotel

PRESENCE OF REINFORCED MARKINGS AND WIG-WAG
