LFOB / Beauvais-Tillé / BVA

This page is intended to draw commercial and private pilots' attention to the aeronautical context and main threats related to an aerodrome. They have been identified in a collaborative way by the main organisations operating, to, on the platform (airlines, airport operator, air navigation service provider, aero clubs, Meteo France...) by comparing items from their respective safety management systems (SMS). Such information has been validated by the members of the Local Safety Teams (LST) of the aerodromes.

Updated by the RLST of 10 Novembre 2021 [updated parts are marked ►]

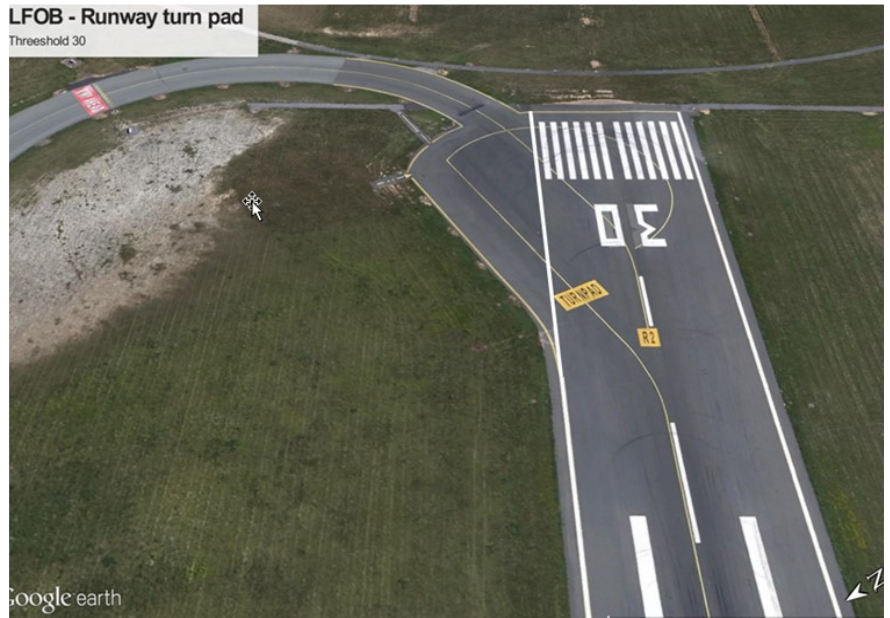
THR 30 (day)

By night or in poor visibility conditions, after landing on RWY 12, possible confusion between the turn pad marks/lighting threshold 30 (first yellow line turning to the left after backtracking RWY 30, green lighting, turn pad marking on the ground) and the Exit R2 (second yellow painted lead-off line, no centerline lighting, R2 marking on the ground).

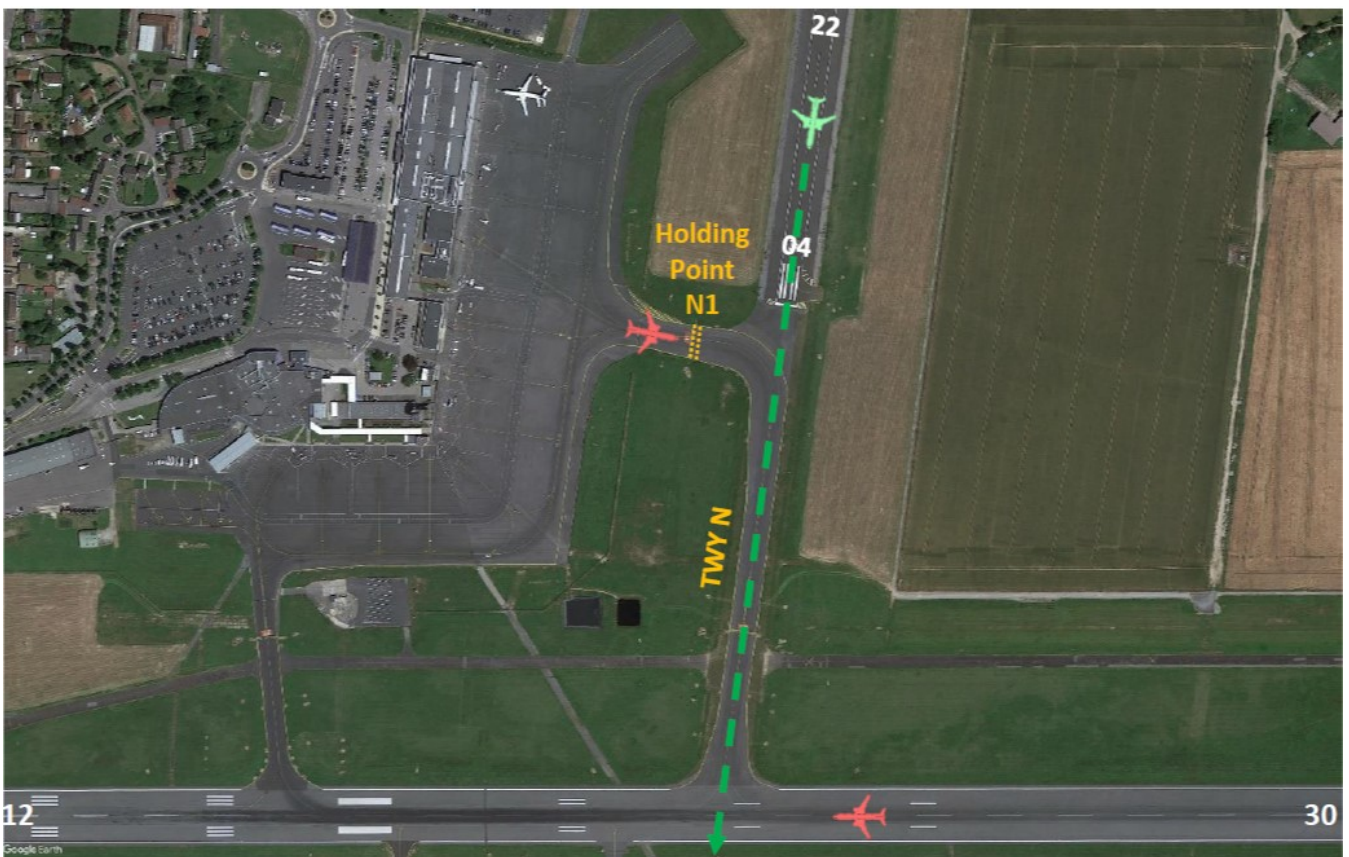
► Risk of runway 04/22 incursion

TWY N is part of the RWY 04/22 protected area. ATC may instruct pilots:

- To hold short of holding point N1
- To backtrack RWY 12 or 30 and hold short of taxiway N well outside of RWY 04/22 axes
- To use non-standard taxi routings to the stand

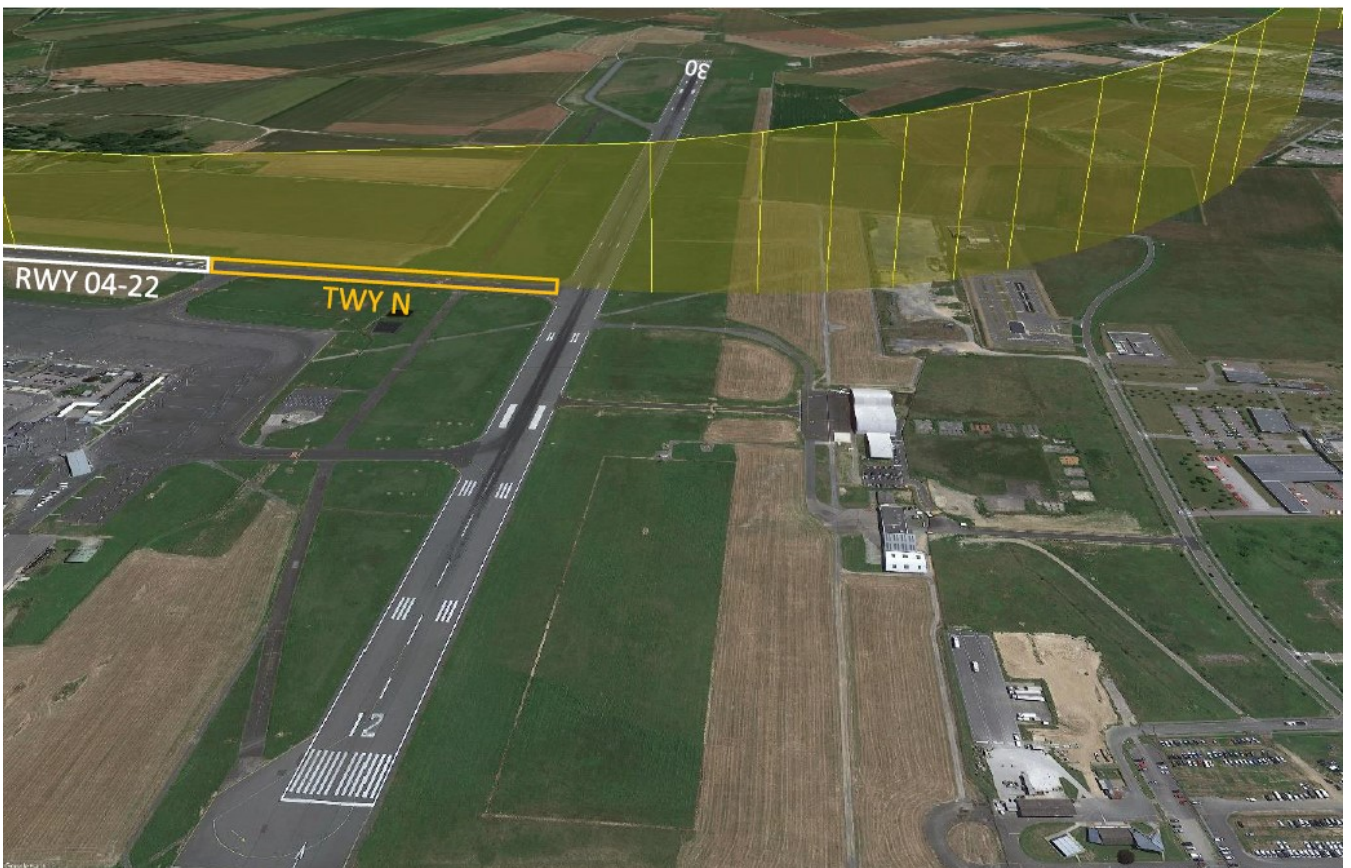
► Risk due to intersecting runways

Take-offs and landings on RWY 04/22 shall avoid low flights over taxiway N and RWY 12/30.

- Take-off from RWY 22 requires positive slope as soon as possible
- Landing on RWY 04, no slope below 3° / 5.2 %
