# LFMP / Perpignan Rivesaltes / PGF

The purpose of this page is to draw the attention of commercial and general aviation pilots to the aeronautical context and the main threats associated with an aerodrome. The identification of these threats is the result of a collaborative effort between airfield operators (air operators, airfield operator, air navigation service providers, flying clubs, Météo-France, etc.) by comparing the elements of their safety management systems (SMS). The members of the Local Runway Safety Team (LRST) validated this information.

## Summary

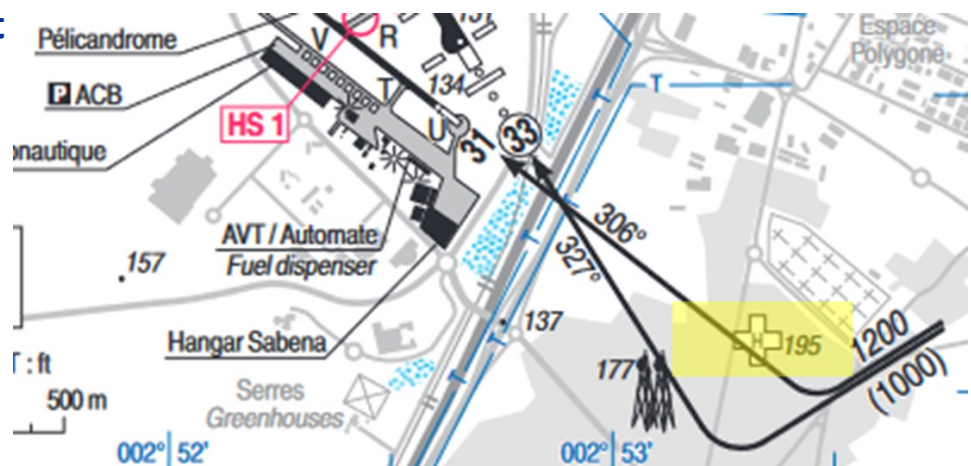
## EMS AND DRAGON flights to and from **HELISTATION** Hospital on runway axis (under short final 31)

- Mountainous environment and non-Standard IFR procedures for relief avoidance
- Traffic with very different technical performances
- EMS flights on hospital near the centreline of runway 33 and threshold 33
- VFR flights along the coast adjacent to IFR 33 procedures
- Zone R 89 in the CTR

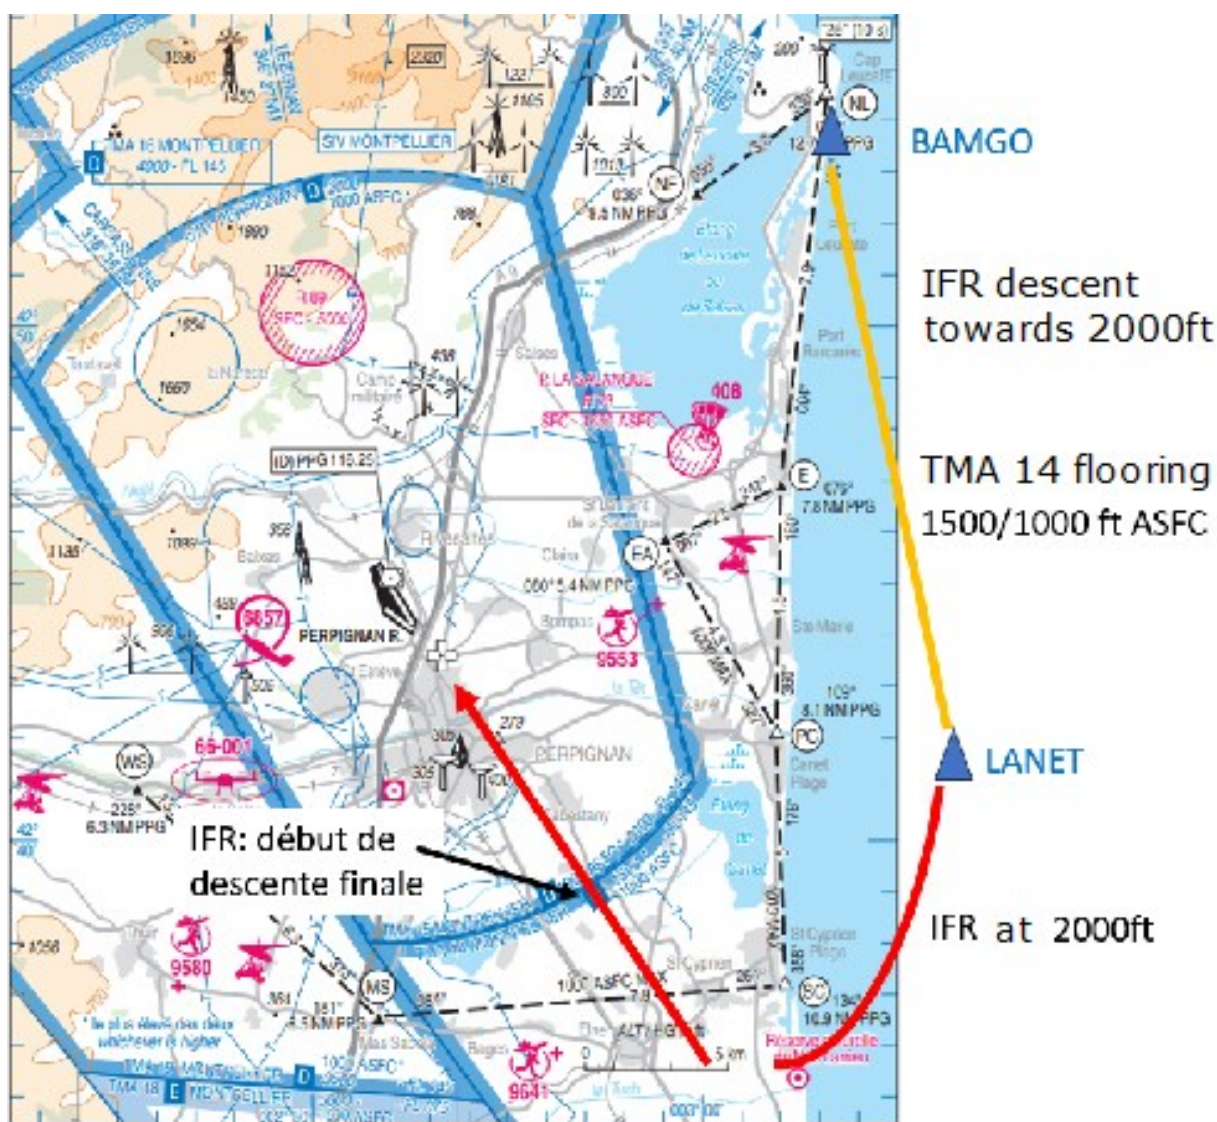
Map VAC AD2 LFMP APP 01 :

### VFR flights along the coast adjacent to IFR 33 procedures

- FR flights in procedure for runway 33 may descend to 2000ft over LANET on clearance from air traffic control.
- Respect the compulsory routes (without radio contact) 1000ft max on the coast

- Avoid the towns of Rivesaltes and Saint-Estève (circled in blue on map AD 2 LFMP APP 01).

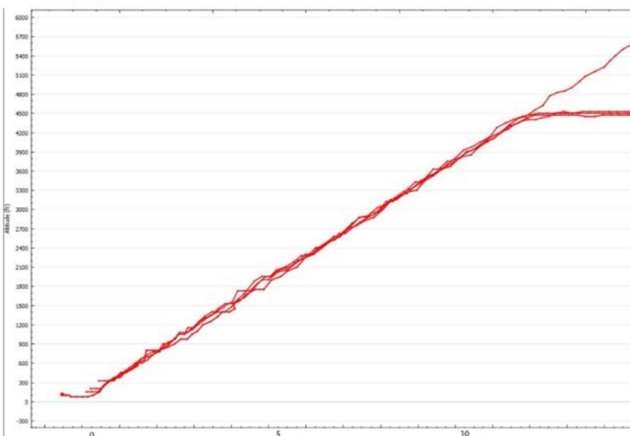
## GPWS alert on RNP15 final

The trajectory of the RNP RWY15 instrument approach procedure at Perpignan flies over a mountainous environment. Since its entry into service in 2020, several in-flight reports of Terrain Awareness Warning System (TAWS) alerts have been sent to the DSNAs by crews using this procedure. The causes identified for these alerts are, depending on the case :

- **The aircraft was put into landing configuration late, with excessive indicated airspeed and/or vertical speed,**
- **Insufficient resolution of the terrain mesh around the approach procedure in the ground database of the aircraft's GPWS - E-GPWS.**

Profils comparés (2 APP en ALR + 2 APP sans ALR)

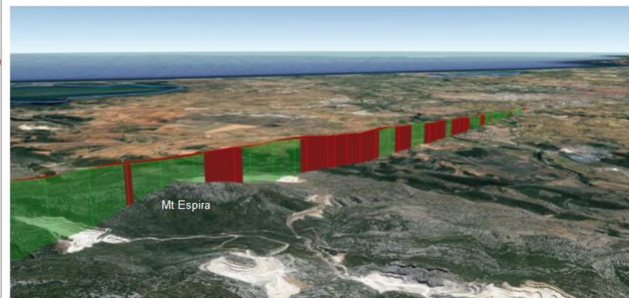
: Profils comparés G. Earth – 1 CRJ en Alerte GPWS (traj. rouge)  
B738 sans Alerte GPWS (Vert)

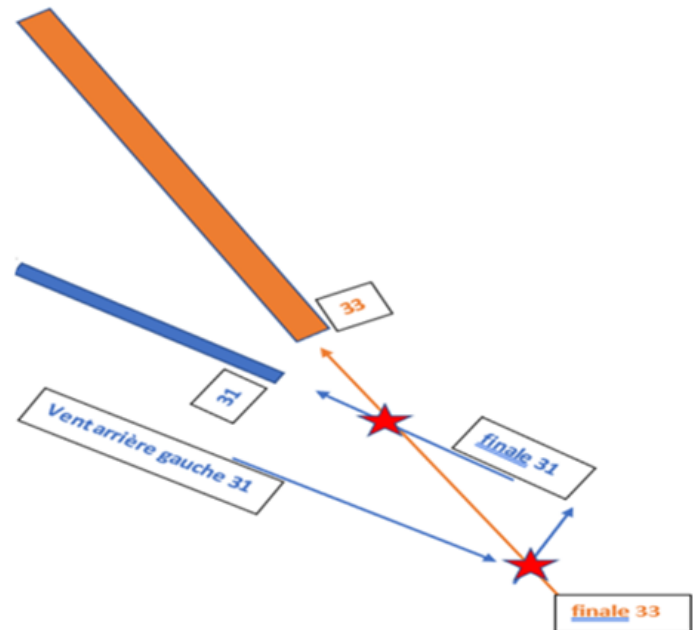
## Convergence of left hand downwind 31 and final 31 with final 33

Follow the control instructions carefully.

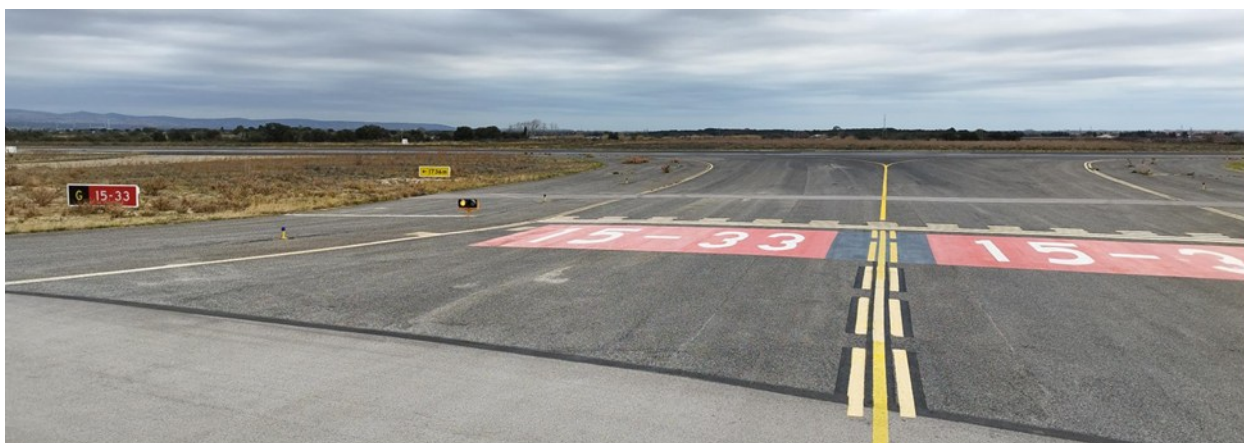
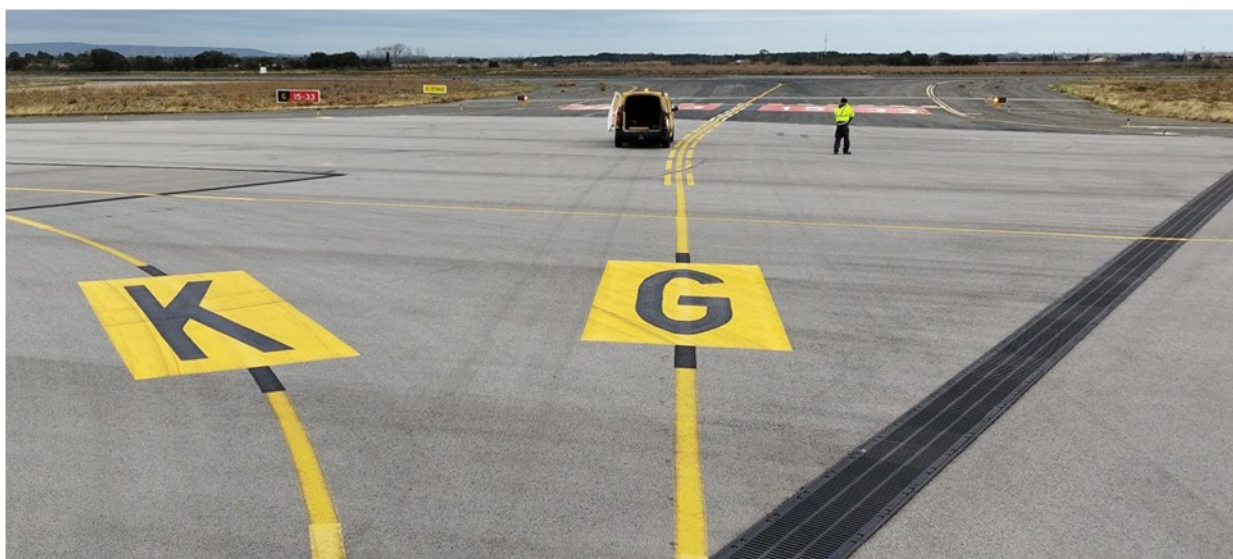
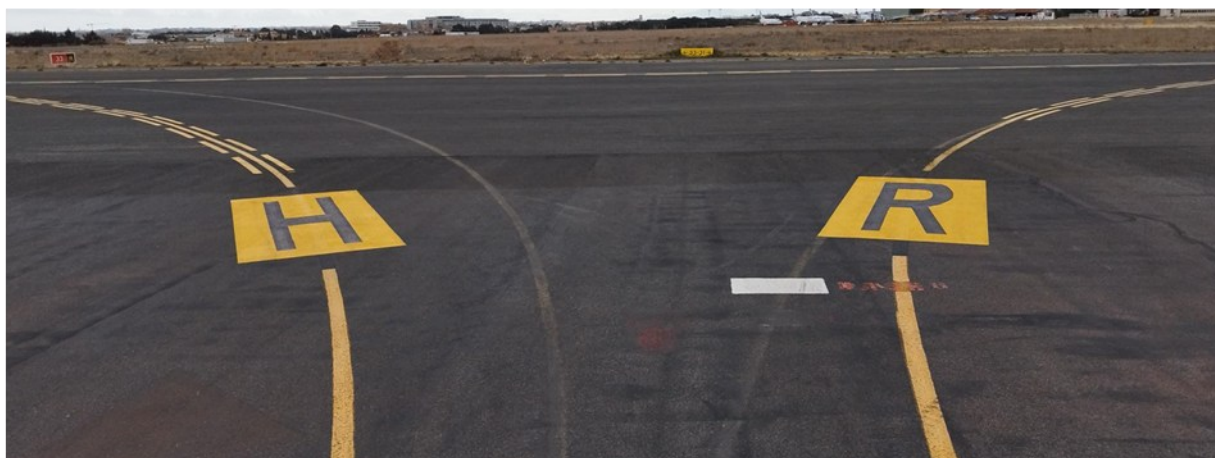
**Very short runway access taxiways: HOT SPOTS ROMEO, GOLF, HOTEL**

The taxiways to the runway holding points are very short on Romeo, Golf and Hotel

**PRESENCE OF REINFORCED MARKINGS AND WIG-WAG**

- Very short runway access taxiways
- Potential risk of sun glare

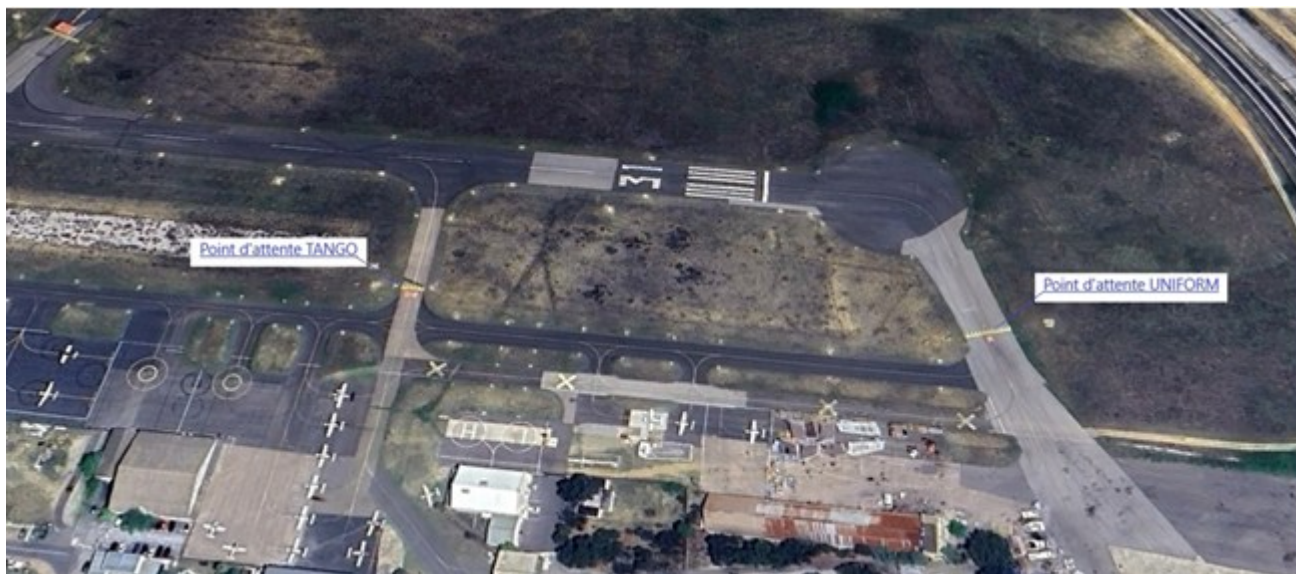
At holding bays TANGO and UNIFORM : occasional risk of glare

In the morning, there is a potential risk of glare while taxiing from the apron of Pôle Aéronautique to holding bays TANGO or UNIFORM (runway entrance facing east). Stay tuned to the frequency and to the control instructions.
