LFMN / Nice Côte-d'Azur / NCE

This page is intended to draw commercial and private pilots' attention to the aeronautical context and main threats related to an aerodrome. They have been identified in a collaborative way by the main organisations operating, to, on the platform (airlines, airport operator, air navigation service provider, aero clubs, Météo France...) by comparing items from their respective safety management systems (SMS). Such information has been validated by the members of the Local Safety Teams (LST) of the aerodromes.

Latest Update: 23/03/2026 by LRST

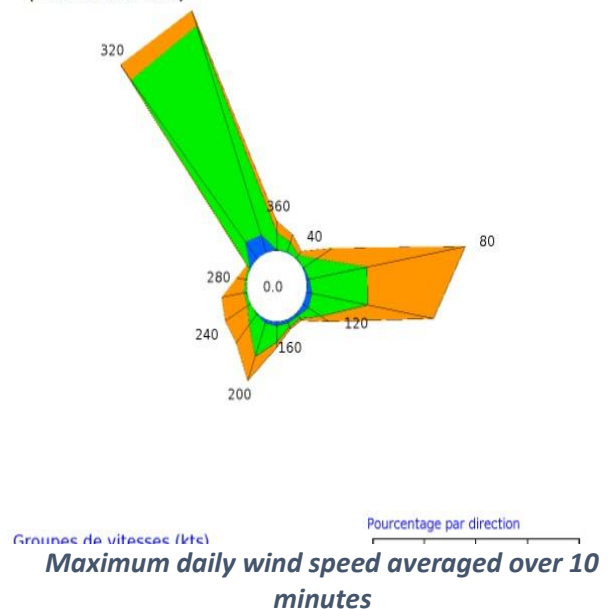
- Winds converge close to the runways, between the breeze from the north-east river valley and the persistent offshore wind, which may generate shear at threshold 04.
- Sometimes violent outbursts of northwesterly crosswinds are channelled through this valley, especially in the rare case of storm cells in the mountains. These gust fronts generate turbulence.

Fréquence du vent maxi quotidien en fonction de son secteur en %
(Période 2000 -2022)

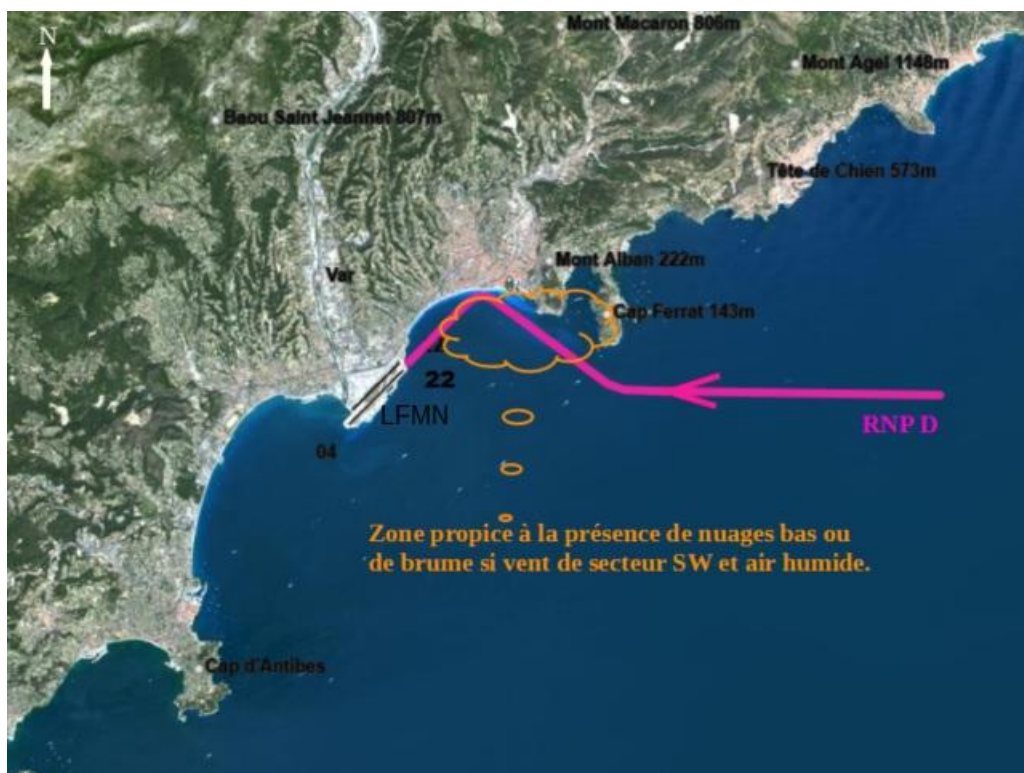
QFU 22 approach: Cap Ferrat and the Mont Alban relief

Does not allow direct precision approaches to QFU 22 and has led to procedures being introduced with VPT and high minima (RNP D and VOR B).

Since 21 March 2024, an RNP AR procedure allows authorised aircraft to fly a circling approach with much lower minima (RNP Z). Under SW wind and moist air conditions, the bay of Nice can become shrouded in mist leading to a lowering of visibility and ceilings, even when the surrounding weather conditions appear to be good.

Under these conditions, the platform accessibility may be compromised and lead to diverting aircraft not authorised to fly the RNP Z (AR).

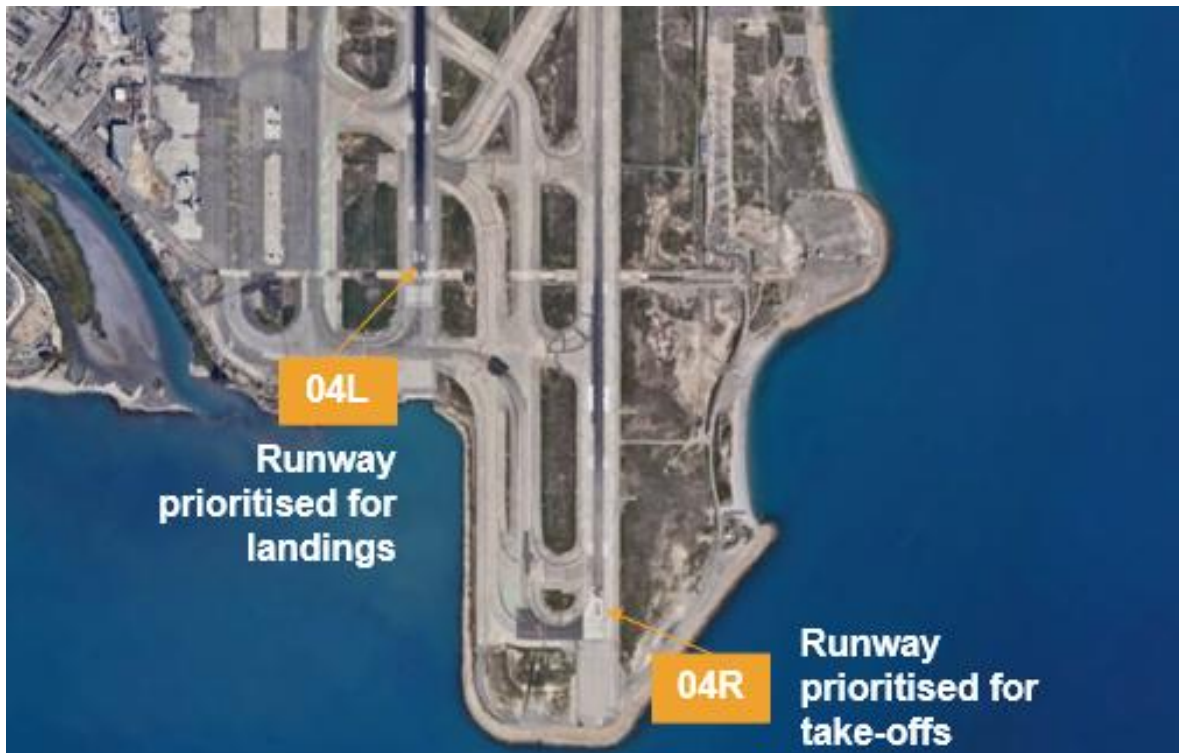
Risk of confusion between parallel runways

The presence of a closely spaced reversed runway pair with similar designations increases the risk of runway confusion.

- **Runway 04L/22R (North) is prioritised for landings.**
- **Runway 04R/22L (south) is prioritised for take-offs.**

For landing, for visual procedures by day and night VPT A, VPT B, VPT D, visual approach, check that you have threshold lights, strobe lights and PAPI to confirm your alignment with the correct runway; the other runway will lack these and will only have take-off lighting.

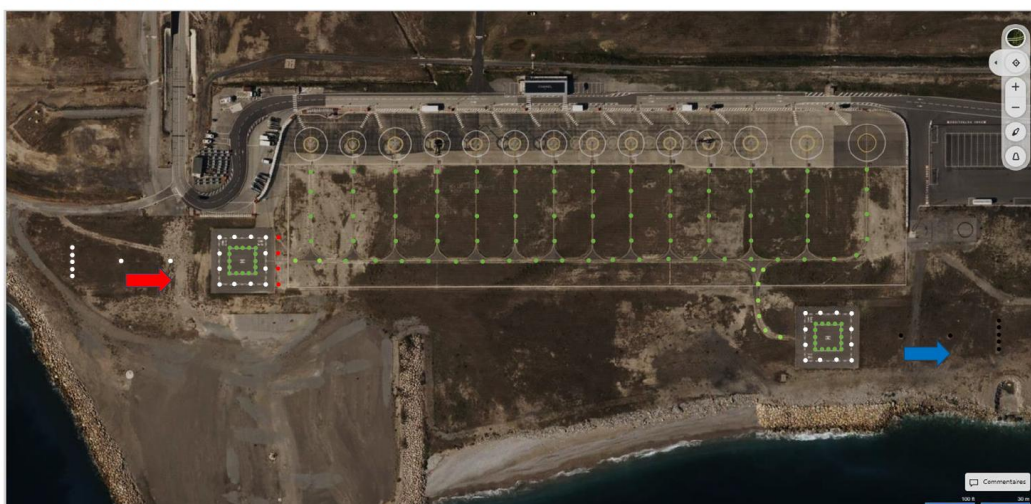
BiFato 04

One way approach red lighting at FATO MS and ME. Unidirectional runway lights facing away from to the FATO.

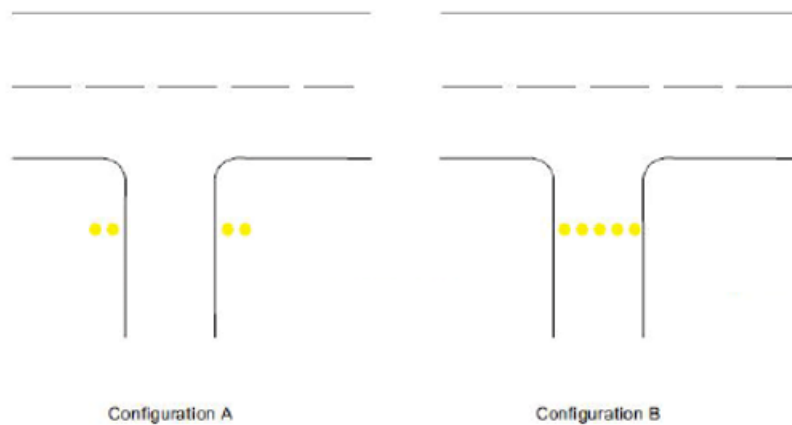
Runway guard lights

The holding points are equipped with runway guard lights with two distinct configurations:

- **Runway guard lights in configuration A+B at the following holding points: A1, B1, C1, F1, EG/G1, H1.** In this configuration, pilots will see a pair of unidirectional lights flashing on either side of the holding point (configuration A) and a line of unidirectional lights embedded in the ground, at intervals of 3m, which flashes (configuration B).
Important: configuration B should not be confused with a stop bar.
- **Runway guard lights in configuration A at the following holding points: A2, A3, B2, B3, C2, G2, H2, H3, J1, W3, Q3, EB, EF, EY.** In this configuration, pilots will see a pair of unidirectional lights flashing on either side of the holding point (configuration A).

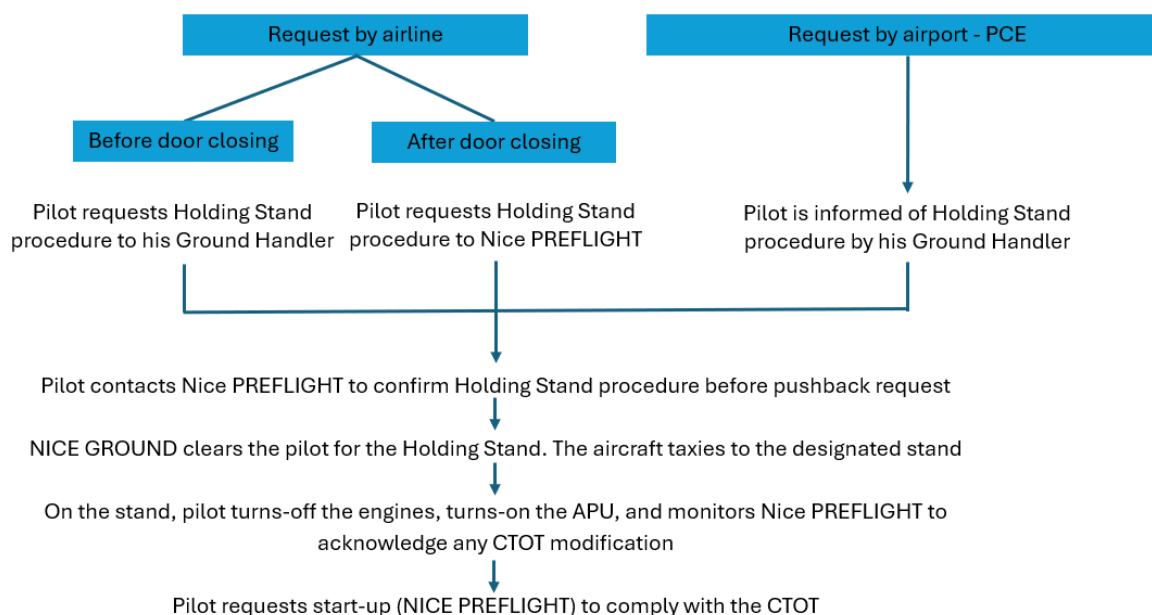
Holding Stand Procedure

Positions used for holding arriving aircraft or for departing flights waiting for a CTOT: **69A/B/C - 67A/B/C - 51B - 53B - 49A/C.**

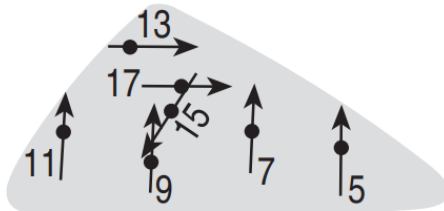
Exit from stands 5 to 17

The parking area aircraft stands 5 to 17 is an area of multiple configurations with remote stands requiring aircraft push-back.

Remote stands: 5, 11, 13 and
Pushback stands: 7, 9 and

This multi-configuration can cause a risk of confusion when leaving a stand. To limit this risk, follow the special markings (arrows) and ATC instructions.
